Manhole Inspection Summary

Manhole # S41E__041MH

Insp Date: **9/12/08 11:08 AM**

Location Address: **side 1401 e fayette st**

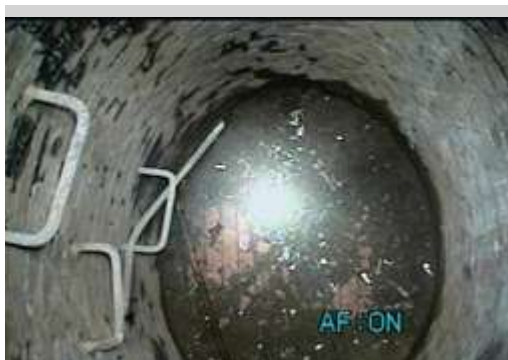
Defect 3

Condition: ☐ Sound ☐ Cracked ☐ Root Intrusion ☐ Deteriorated ☐ Leaks ☒ **Debris**

channel debris

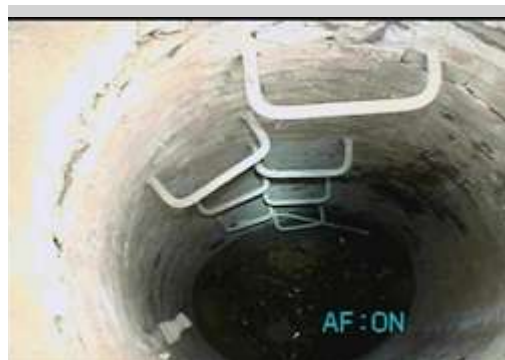
Defect 2

Count: **7** Missing: **0** ☒ **Corroded**

steps

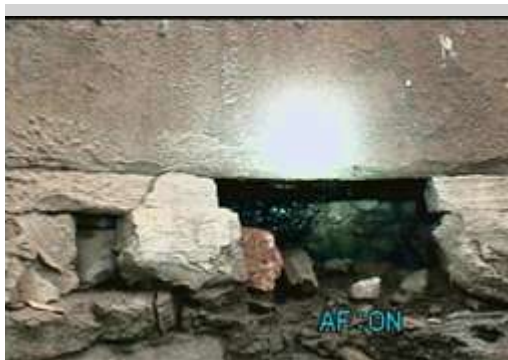
Defect 1

Condition: ☐ Sound ☒ **Cracked** ☐ Root Intrusion ☒ **Loose Brick** ☒ **Deteriorated**

chimney cracked, deteriorated & has loose bricks

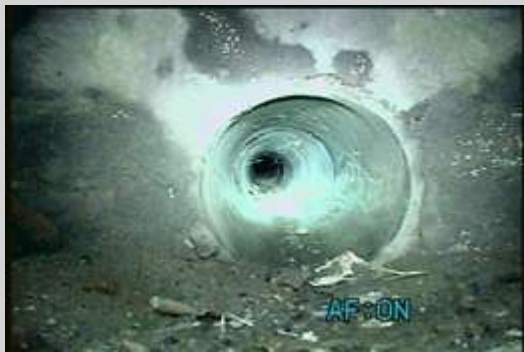
12 O'Clock Outflow

8 in. Circular Gravity Sewer
Pipe Out @ 12 O'Clock

Pipe Material: **Clay** ☐ Pipe Lined

Invert Depth: **10.66** (ft.) Flow Characteristics: **None**

Infiltration: **None** Pipe Seal Cond: **Unknown**
